Mulkey-Monache Grazing Allotments, Golden Trout Wilderness
Head Cut and Photo Point Monitoring, 2003 and 2011 (DRAFT)

By: Casey Shannon, Hydrologic Technician
Inyo National Forest, Supervisor's Office
January, 2012

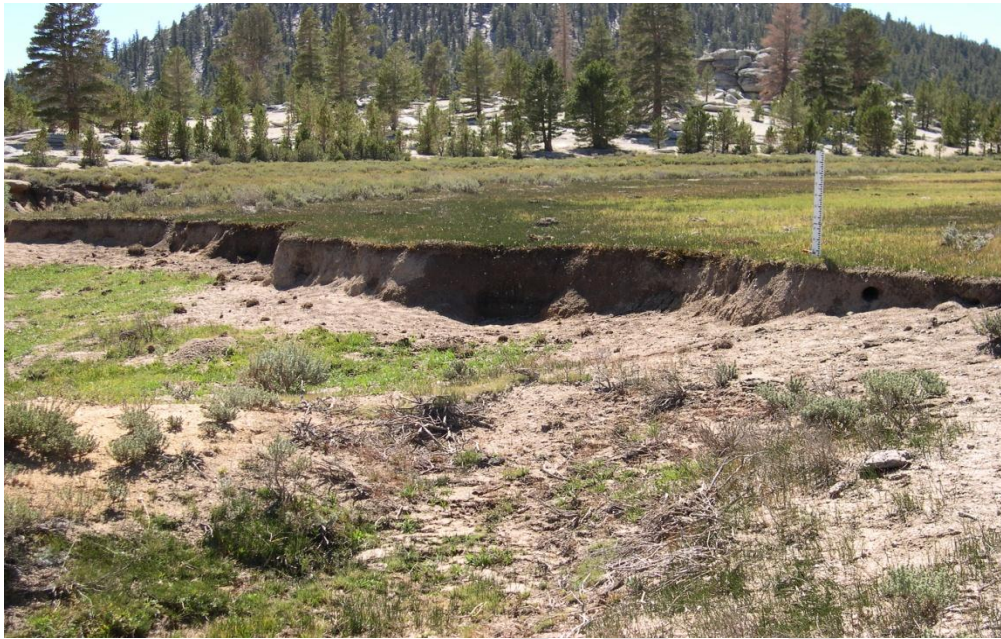
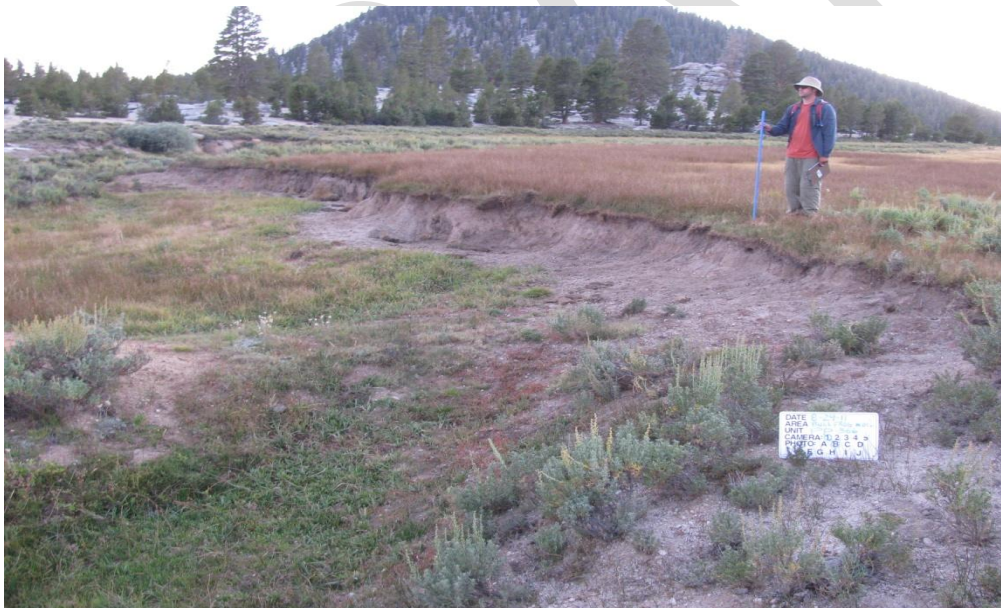
Above photo: Photo-point 366 (PP-366), lower Bullfrog Meadow, August 2003. Site is a degraded terrace bank and edge of riparian wet meadow above historically incised channel (Bullfrog Creek) with actively eroding soil and sod layer. Overland flow from the wet meadow can move over the terrace edge at times. **Below photo:** PP-366 photo re-taken August 2011. The terrace face is still in a state of active erosion and soil loss is occurring, although slightly less than in 2003. Increased riparian vegetation has moved upslope on bare soil area and is starting to fill in and stabilize channel banks. Overall, there is a slight to moderate upward trend at this site. Wetland riparian vegetation has increased in vigor on the area above the eroded terrace edge. Off-site soil movement has lessened.

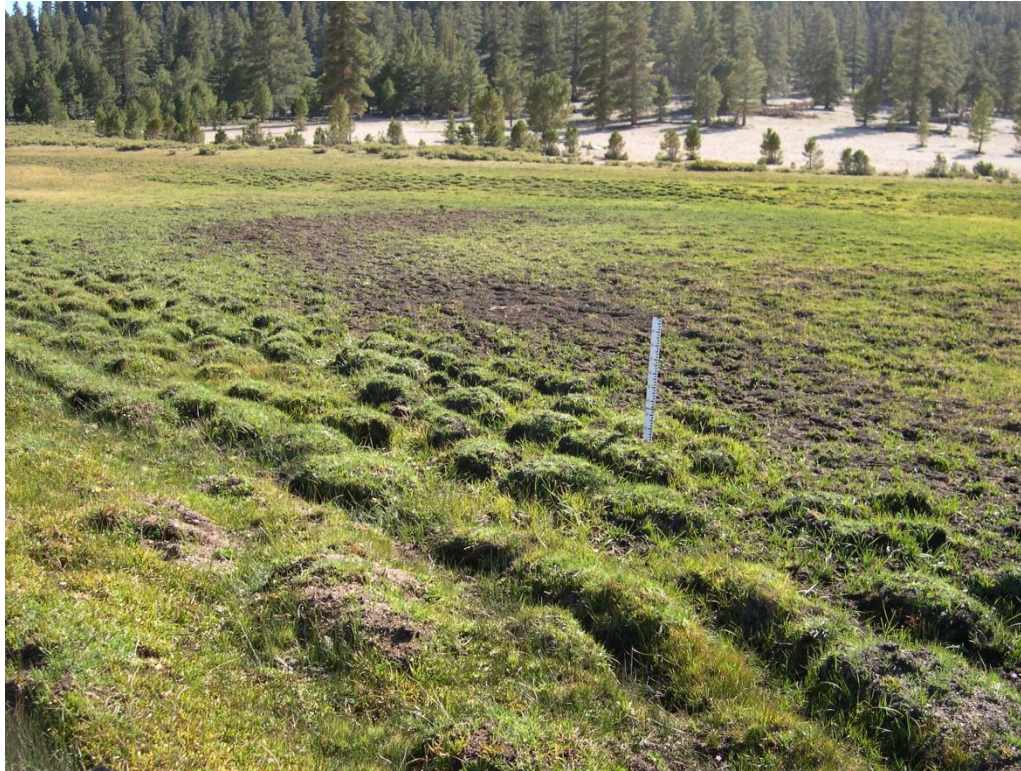
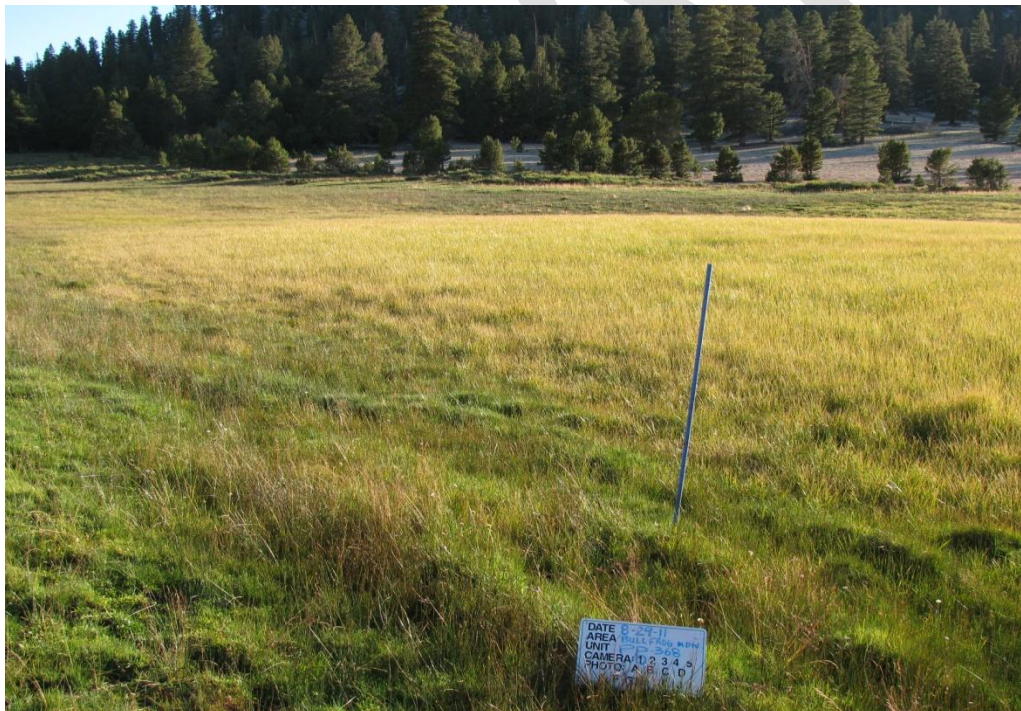
Above photo: Photo-point 368 (PP-368) Bullfrog Meadow, August 2003. Site is a wetland area (possible fen) exhibiting signs of overgrazing, wide spread hummock formation with soil compacted trailing pathways and fragmented organic sod layer. **Below photo:** PP-368 Bullfrog Meadow with photo re-taken August 2011. A noticeable amount of recovery at this site occurred since 2003. Hummock formations have lessened in size and scale, organic soil cover has improved considerably and the local water table is now on the surface in the meadow.

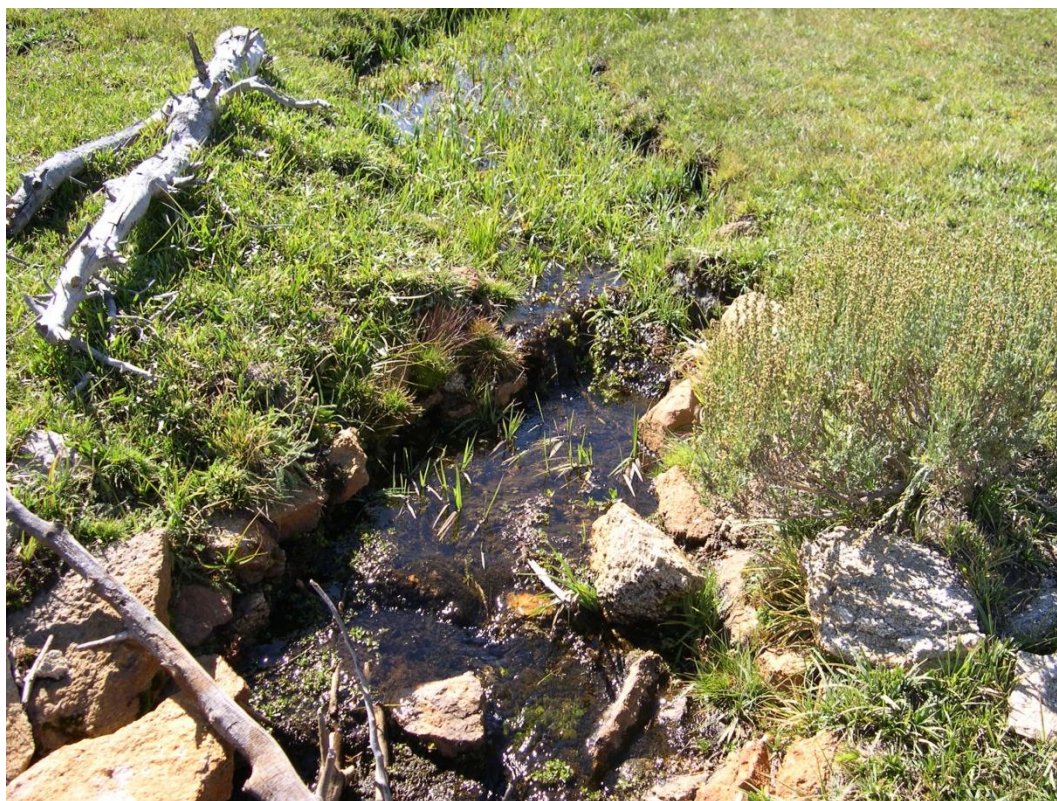
Above photo: Treated Head Cut 367 (THC-367) Bullfrog Meadow, July 2003. THC 367 is a head cut that was treated using filter cloth and rock chute armoring in the early 1990's adjacent to PP-367 (one of two once active headcuts at the top of the incised channel of Bullfrog Creek). **Below photo:** THC-367 Bullfrog Meadow photo re-taken August 2011. Rock chute has become vegetated, filled in with sod and stable, meeting prescription.

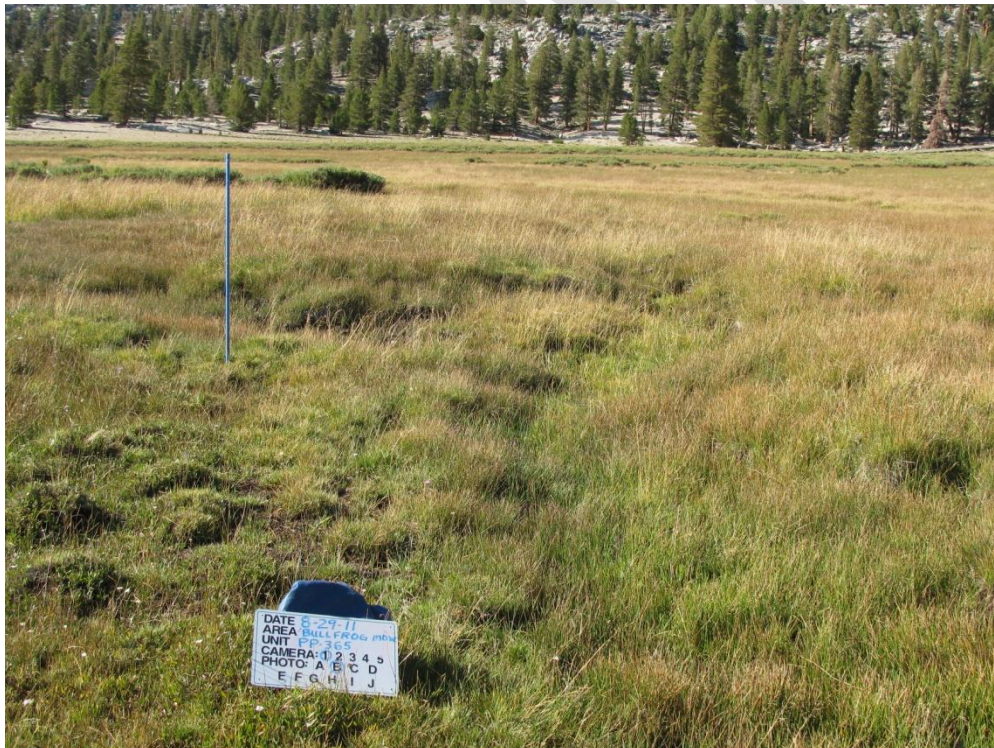
Above photo: Photo Point 365 (PP-365), Bullfrog Meadow photo taken July 2003. The site is an eroded wet meadow area with moderate hummock formations and pockets of exposed, partially eroded organic soil.

Below photo: PP-365 Bullfrog Meadow, photo re-taken August 2011. Hummock formations have lessened in scale and size although still present with less soil exposed. Riparian vegetation has filled in to a large degree over the site helping to stabilize fragile wet soil and the area of exposed soil has been significantly reduced. An upward trend exists at site.

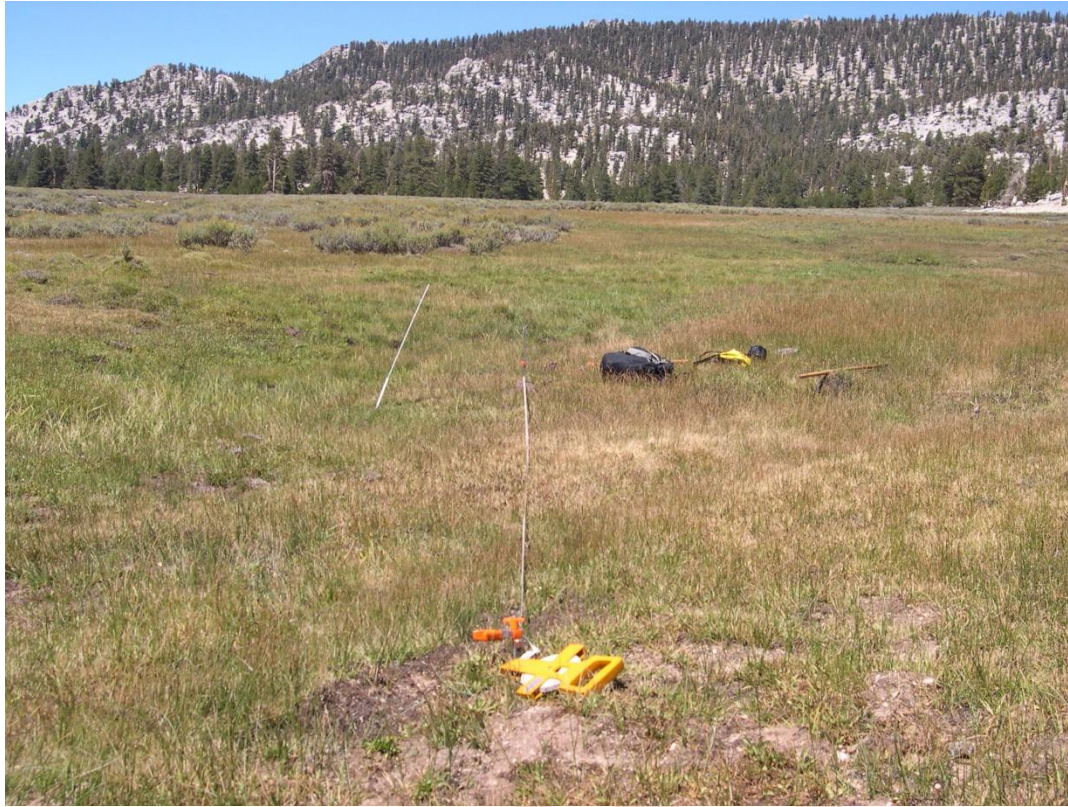
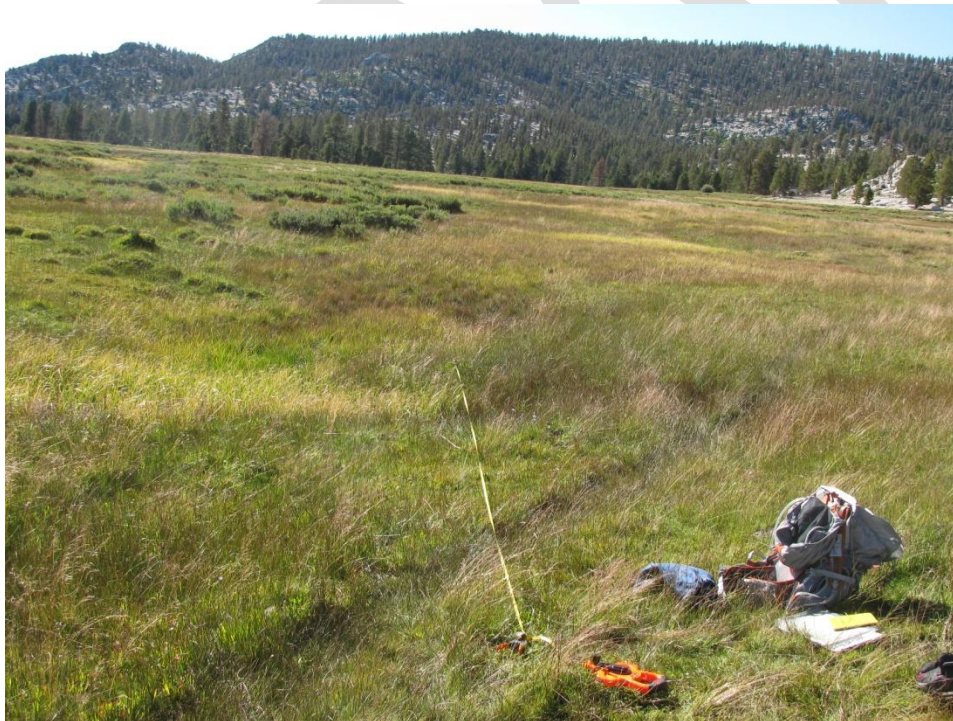
Above photo: Head cut 364 (HC-364) looking from right bank upstream towards left bank, photo taken July 2003. Extended tape shows location of headcut. Vegetation at the site appears to be less vigorous in 2003. **Below photo:** HC-364 with photo re-taken August 2011. Riparian vegetation has filled and growth increased, adding to overall stability at this site. HC has moved 0.20 meters and under normal conditions should not be a threat for migration.

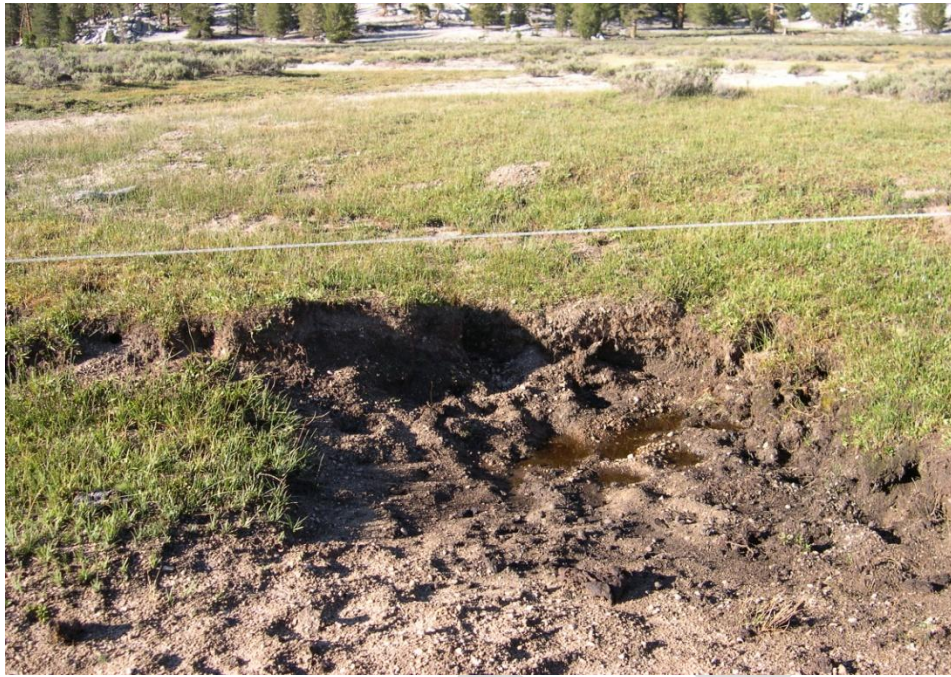
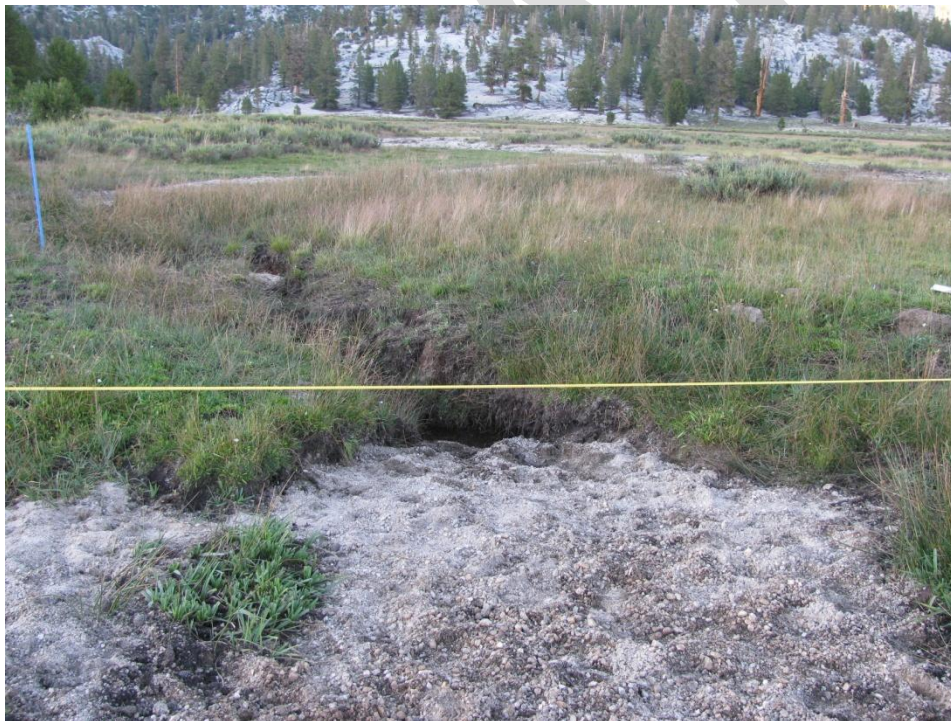
Above photo: Head cut 369 (HC-369), Bullfrog Meadow, July 2003. An active headcut on a low gradient tributary reach to Bullfrog Creek with deep alluvial subsoil (decomposing granite) with a thin organic sod layer thickness. This site is subject alluvial deposition from steep watershed upstream. **Below photo:** HC-369 with photo taken August 2011. Head cut has migrated 7.5 meters, and has formed into two active points. Channel width above HC is narrow as controlled by bank of robust sod above 2003 HC location. HC migration potential is moderate due to low gradient and ability of flood water to spread overland that tends to dissipate flow energy at headcut point(s). This site could be treated for HC stabilization.

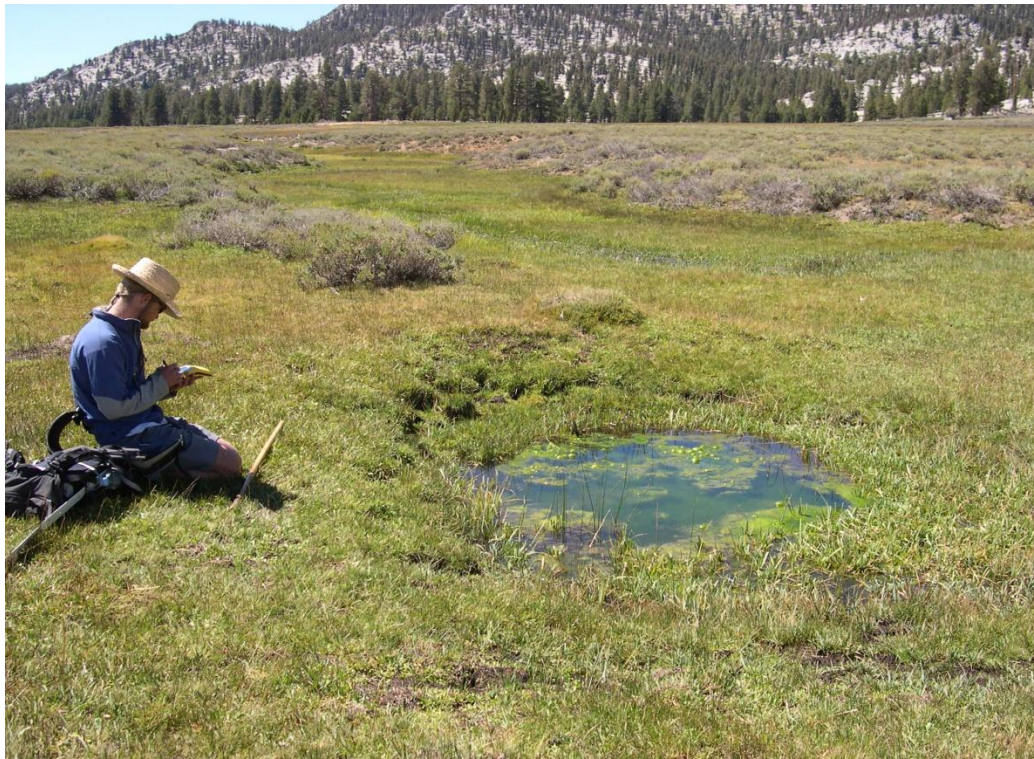
Above photo: Spring pool on south bank of Bullfrog Creek, Bullfrog Meadow August 2003. Algae content in pool obvious, floodplain of Bullfrog Creek in background. The banks around the spring pool are moderately impacted by grazing activity. Water quality appears to be adversely affected by nutrient loading. Three adult Mountain yellow legged frogs were seen in pool at this time. **Below photo:** Spring pool at Bullfrog Meadow photo re-taken August 2011. Banks are stable with robust vegetation and water quality appears to be improved, much less algae development. Floodplain vegetation along Bullfrog Creek channel is more robust and appears to be elevating towards terrace. Frogs were not present at this time of observation.

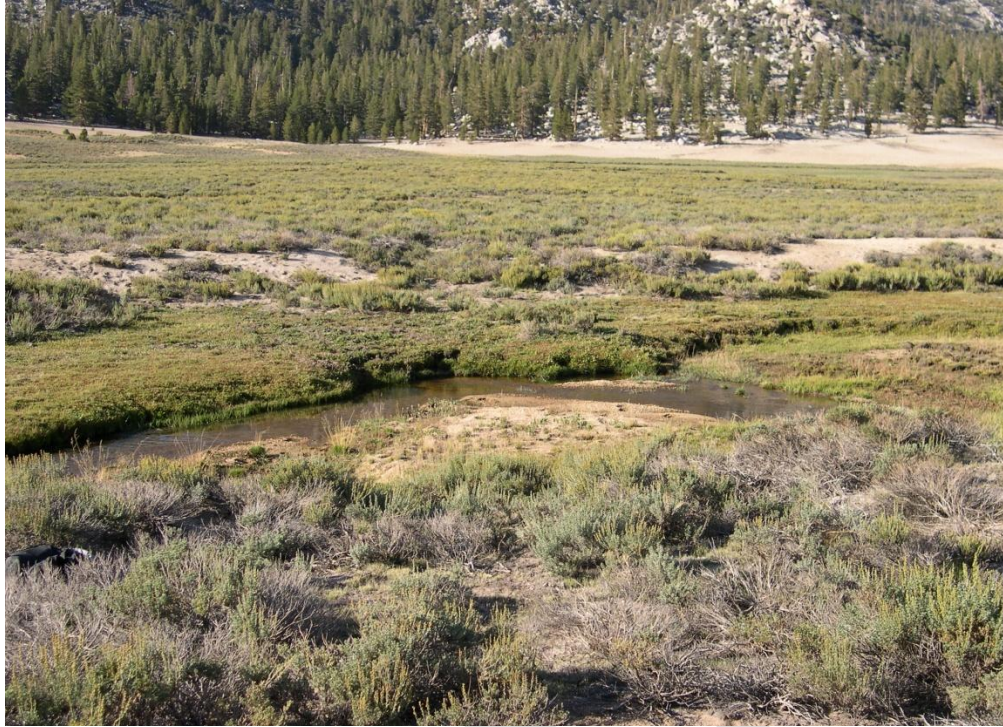
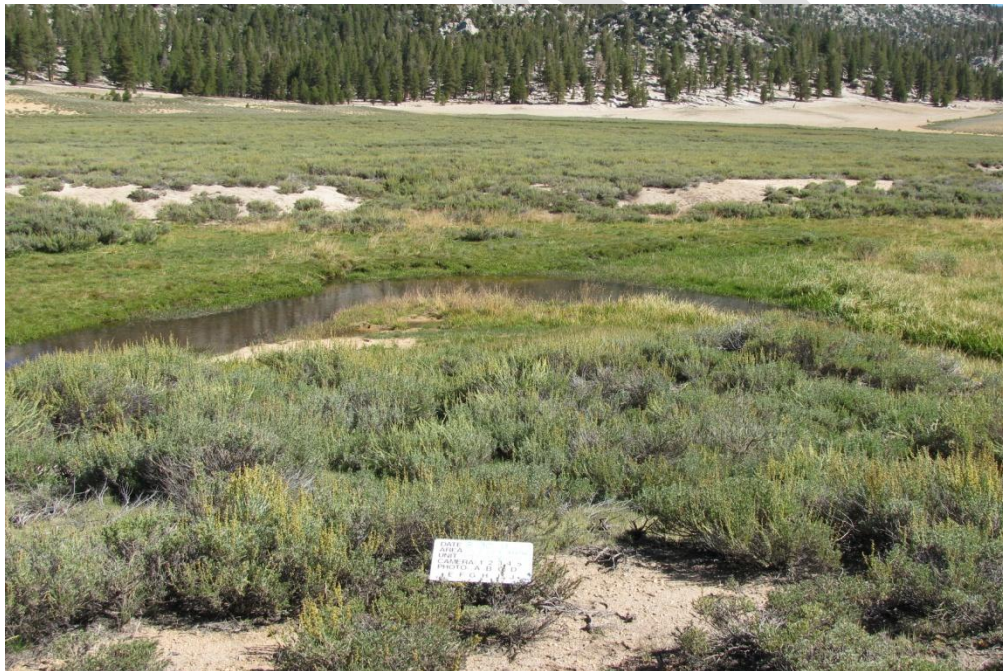
Above photo: Photo-point 356-2A (PP-356-2A), Mulkey Meadow July 2003. Site is a meander bend of Mulkey Creek with abandoned floodplain terrace above channel valley. Vegetation on point bar on south bank has thin vegetative cover and banks on north partially eroded with partial sod missing. Terrace slopes sandy. **Below photo:** Same site with photo retaken August 2011. Point bar on south bank (foreground) has vegetated and stabilized, north banks filled in with vegetation and erosion has slowed on banks, overall an increase in riparian cover. Riparian vegetation extent has increased upwards to terrace slightly. Vegetation on terrace banks is slowly increasing. Site is a repeat of La Barbara 1991 photo.

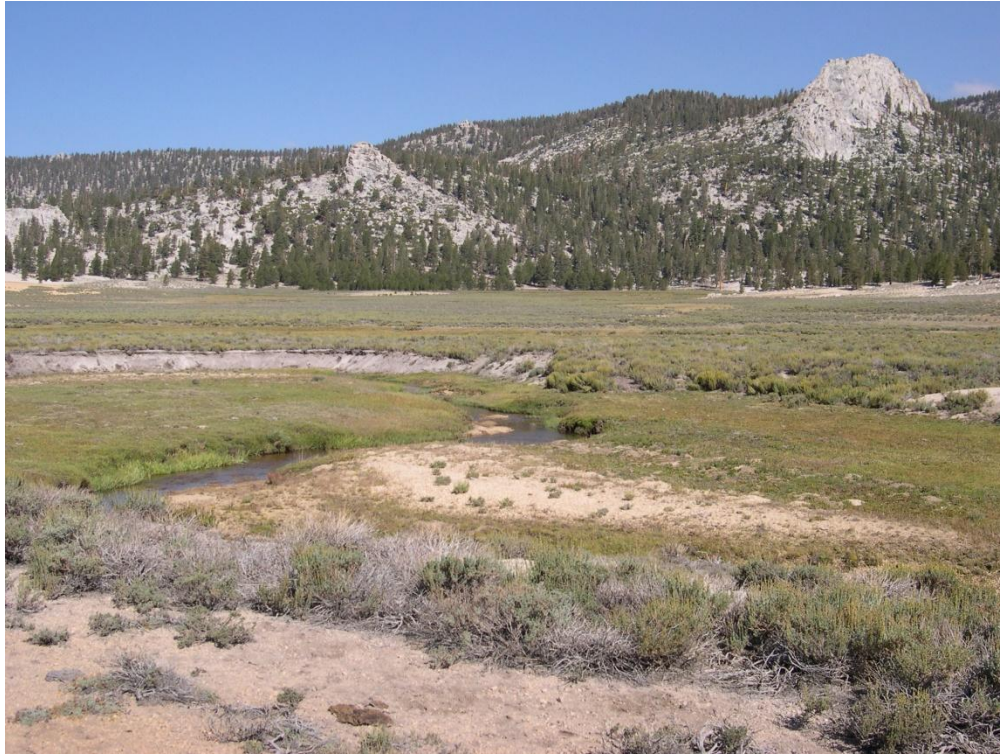
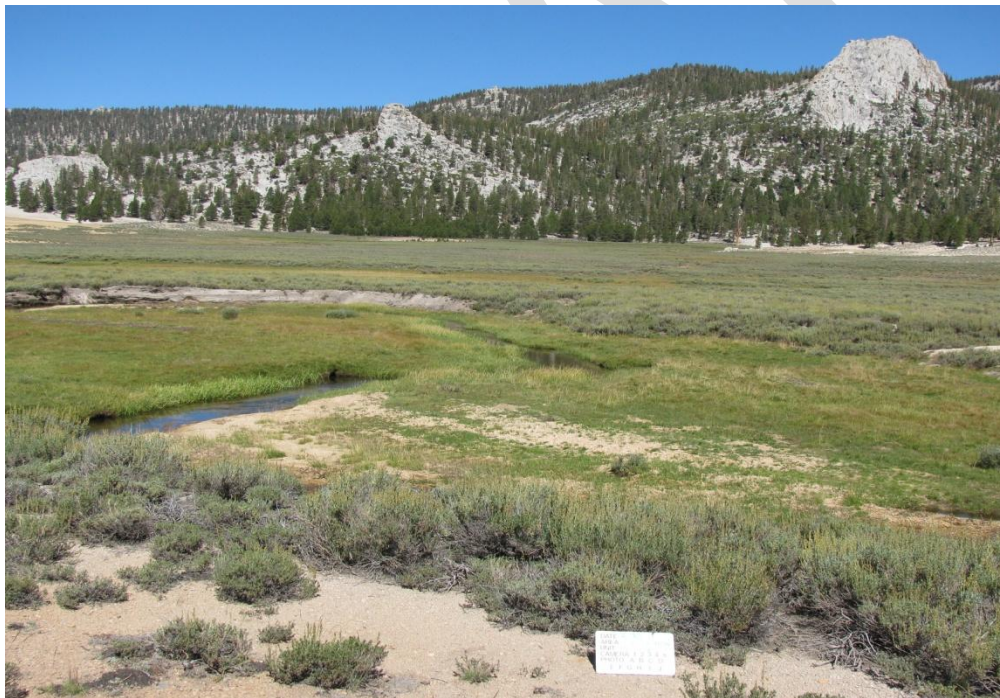
Above photo: Photo-point 356-1C (PP-356-1C), Mulkey Meadow photo taken August 2003. Site is of a multiple meander bend on Mulkey Creek within an older incised stream bed with adjacent terraces. Point bar in foreground has light vegetative cover and channel banks are partially eroded. **Below photo:** Photo-point 356-1C with photo retaken August 2011. The large point bar in foreground is showing signs of light to moderate vegetative recovery, stream bank erosion has slowed and smaller point bars downstream have fully vegetated, showing moderate increase in channel stability at this site. Site is a repeat of La Barbara 1991 photo.

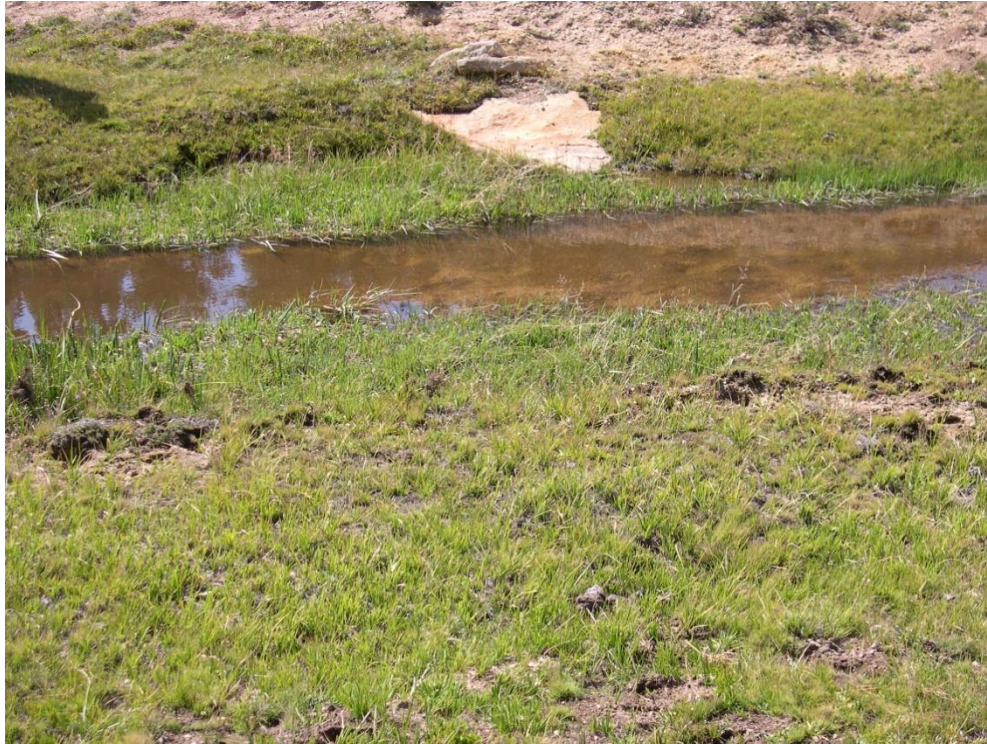
Above photo: Photo taken July 2003, Photo-point 357-2A (PP-357-2A), Mulkey Meadows looking across channel bottom cross section on Mulkey Creek. Sod layer along stream banks is fragmented with bare soil areas. Riparian vegetation density is moderate at site and stream channel is over-widened. **Below photo:** Photo-point 357-2A with photo retaken August 2011. Streamside vegetation has increased and is much denser in coverage, improving hydrologic function. Stream channel has narrowed and banks are stable. Site is a repeat of La Barbara photo 1991.

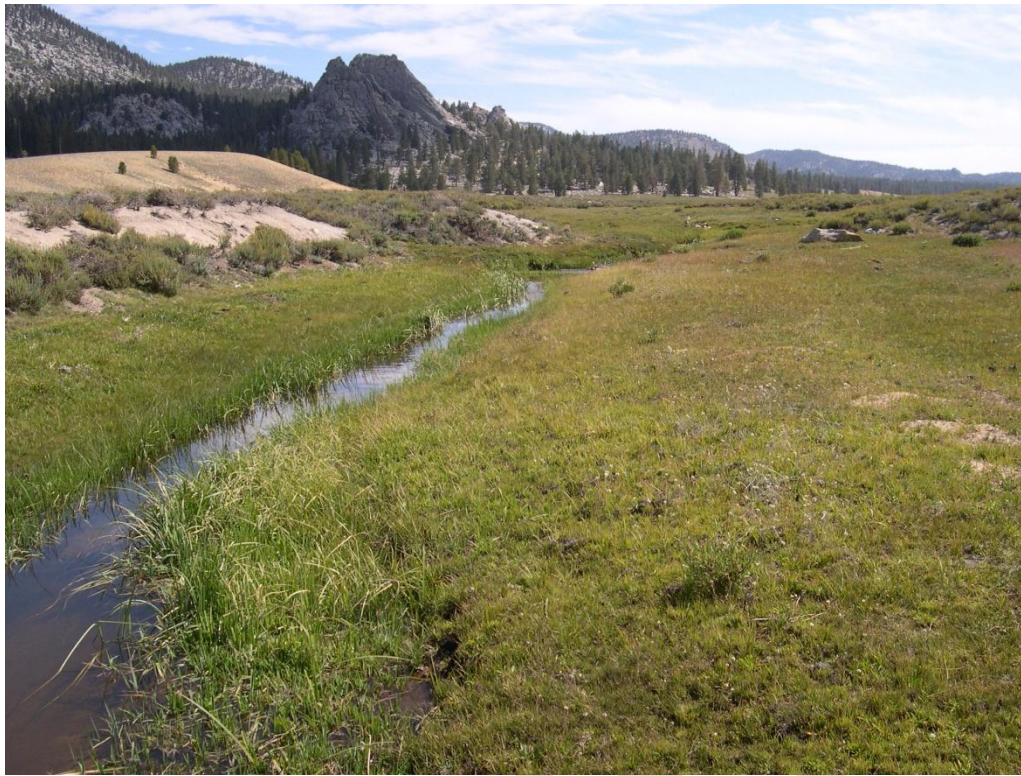
Above photo: Photo-point 357-1B (PP-357-1B), Mulkey Meadow along Mulkey Creek, August 2003. Site is a straight reach looking along stream side flood plain and channel. Some bank erosion is noticeable in foreground.

Below photo: Same site with photo retaken August 2011, Riparian vegetation along stream channel has increased and stream banks are more stable, willow recruitment is apparent. Slight upward movement of riparian vegetation growth on terrace slopes is noticeable. Site is a repeat of La Barbara 1991 photo.

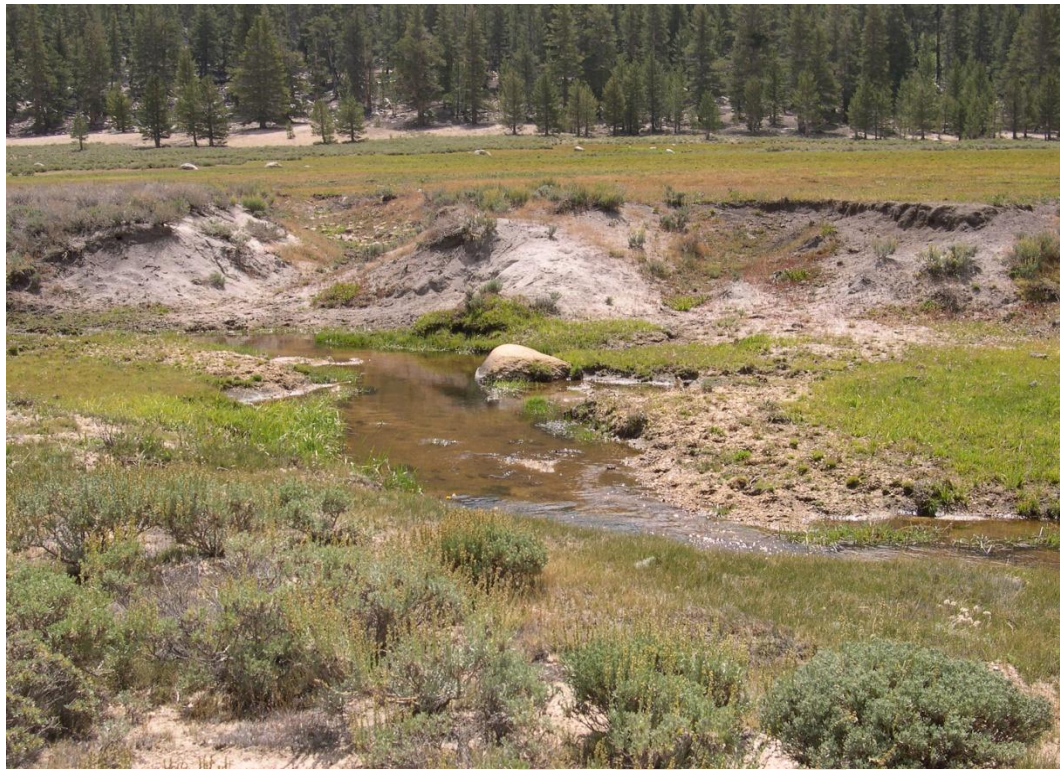
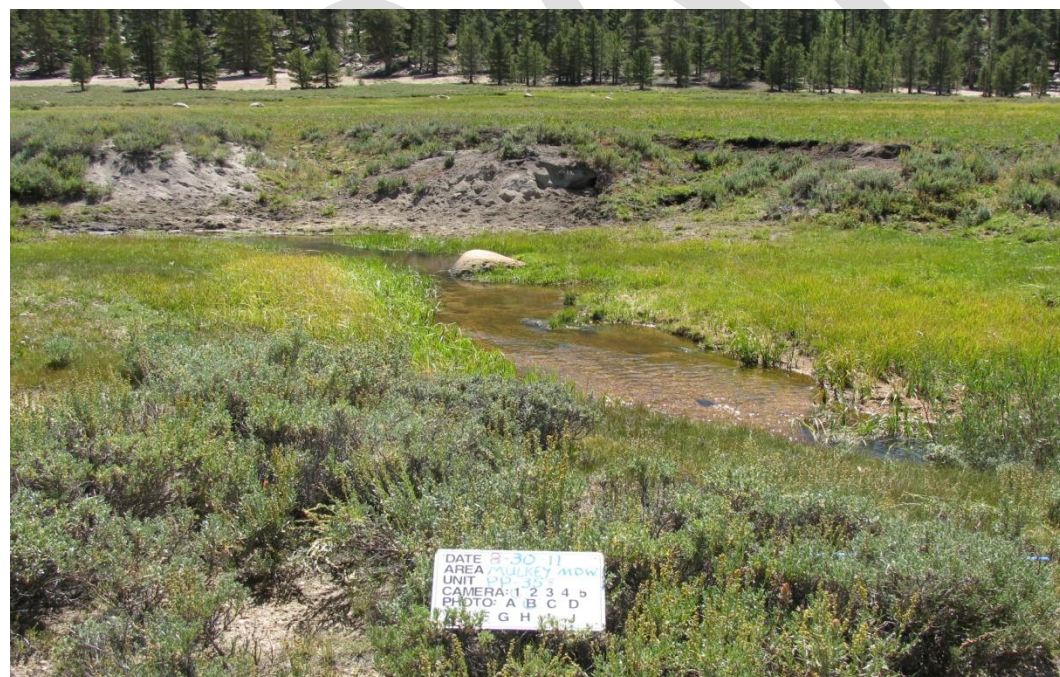
Above photo: Photo-point 358, (PP-358) Mulkey Meadow along Mulkey Creek photo taken August, 2011. Site is an eroded terrace bank with headcuts in the two lateral gullies that were treated in the 1980's. Terrace banks were contributing sediment to the channel and lower stream banks in an eroding condition with missing, fragmented sod and thinned riparian vegetation. **Below photo:** Same site with photo retaken August 2011. Terrace banks have increased vegetative cover, more in the gullies and streamside vegetation cover has increased, channel is starting to narrow as floodplain vegetation is recovering.

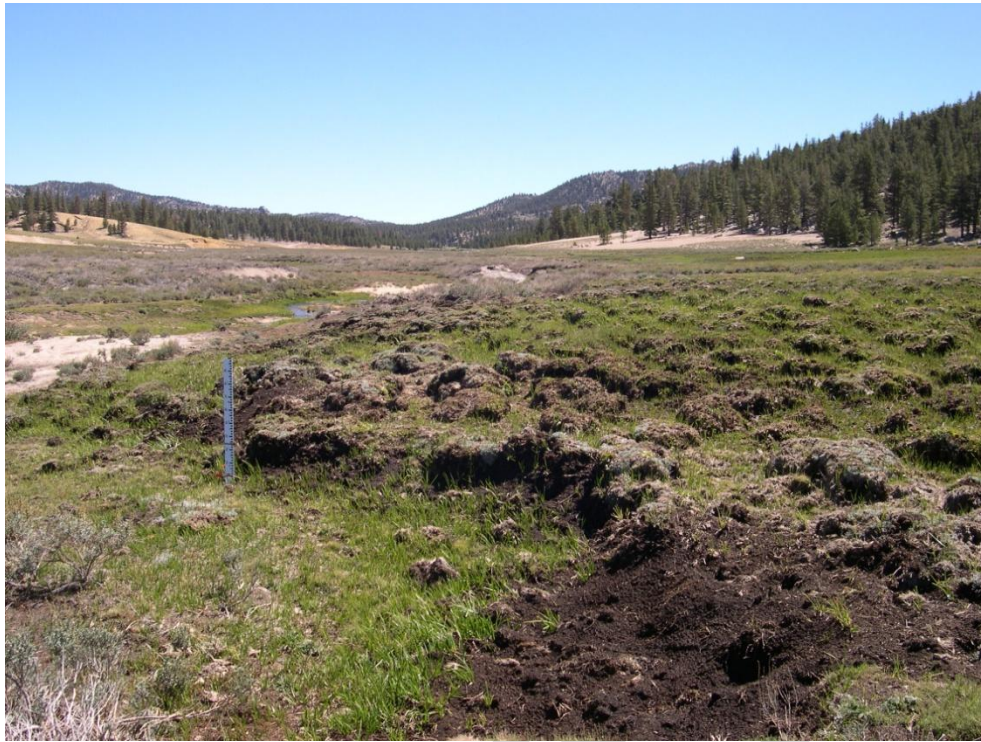
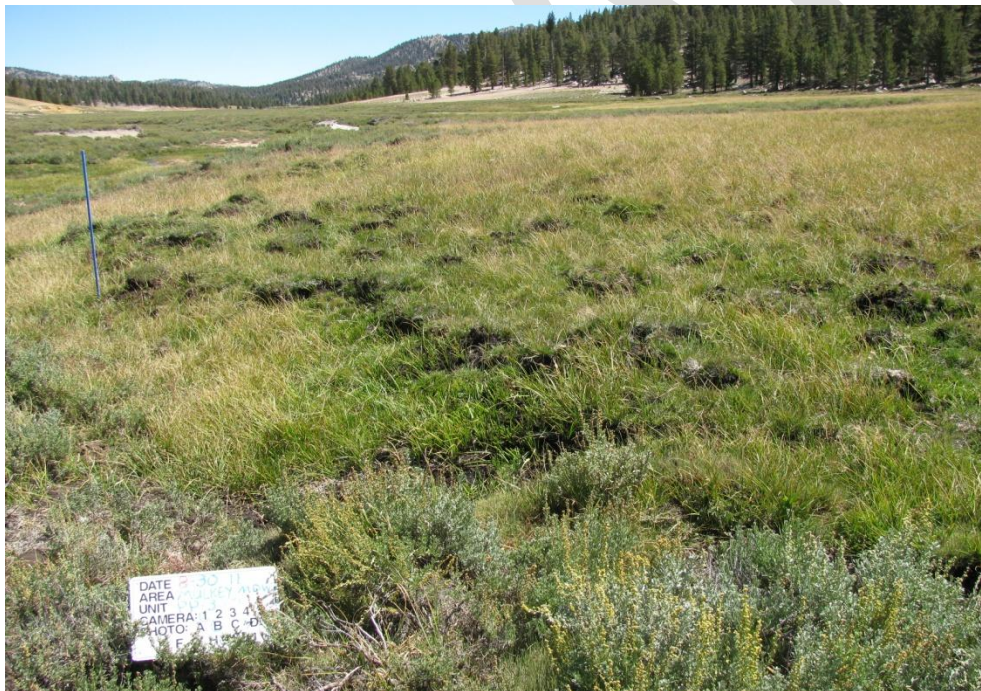
Above photo: Photo-point 370 (PP-370) Mulkey Meadow, August 2003. Site is an area along Mulkey Creek of widespread, eroded large hummock formations with missing and fragmented sod cover located in a wet meadow area (possible fen). **Below photo:** PP-370 with photo re-taken August 2011. Hummock formations have lessened in shape in scale, erosion has decreased and vegetative cover has increased. Hummocks are present with improved soil protection due to increased riparian vegetation. Site is stabilizing in an upward trend and is still in a delicate condition. Streamside vegetation cover has improved along Mulkey Creek stream banks.

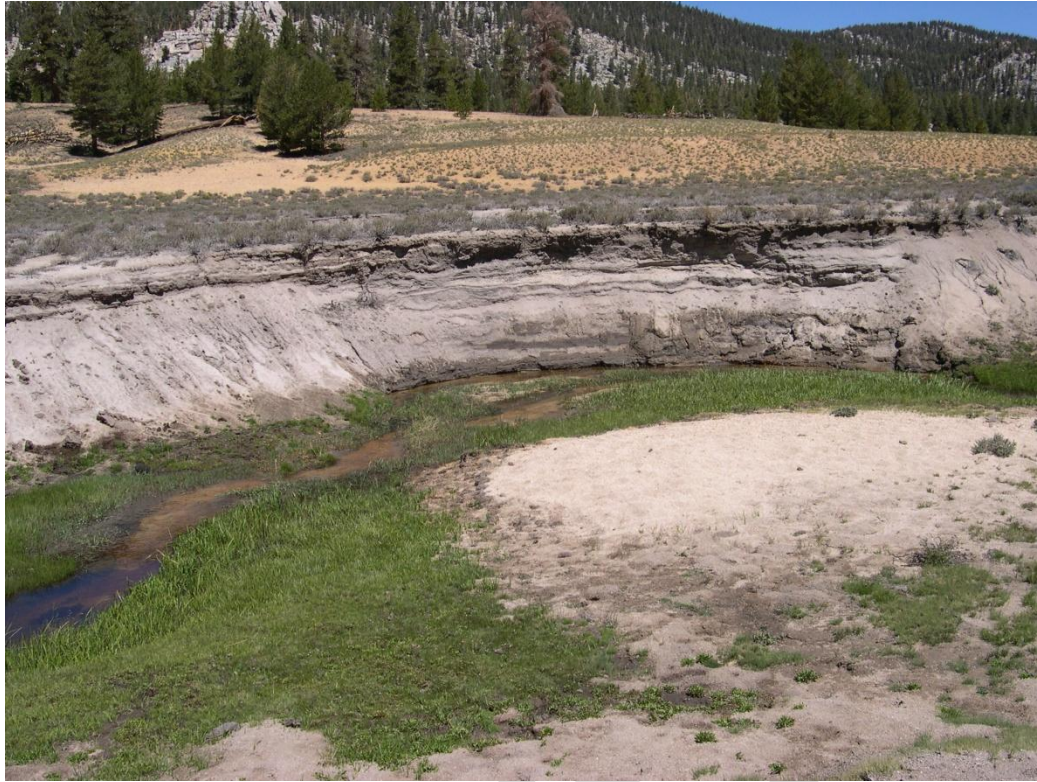
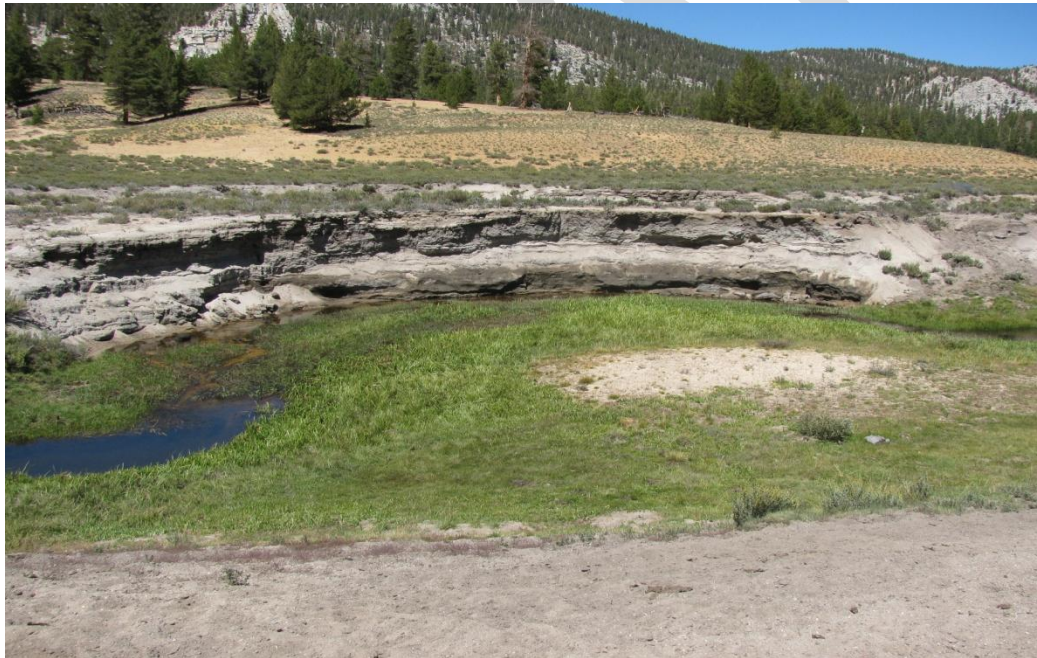
Above photo: Terrace bank along Mulkey Creek (non-photo point) photo taken August 2003. Stratigraphy of bank shows old layers of organics and sandy outwash materials. Terrace top level was possibly where most recent floodplain existed before major channel incision occurred at Mulkey. Point bar on bottom has a wide area of bare ground. **Below photo:** Terrace bank along Mulkey Creek photo retaken August 2011. Terrace slope is more defined with less dry raveling occurring. Point bar is approximately 60 % covered with new vegetation. This area shows there has recently been a high amount of grazing pressure.

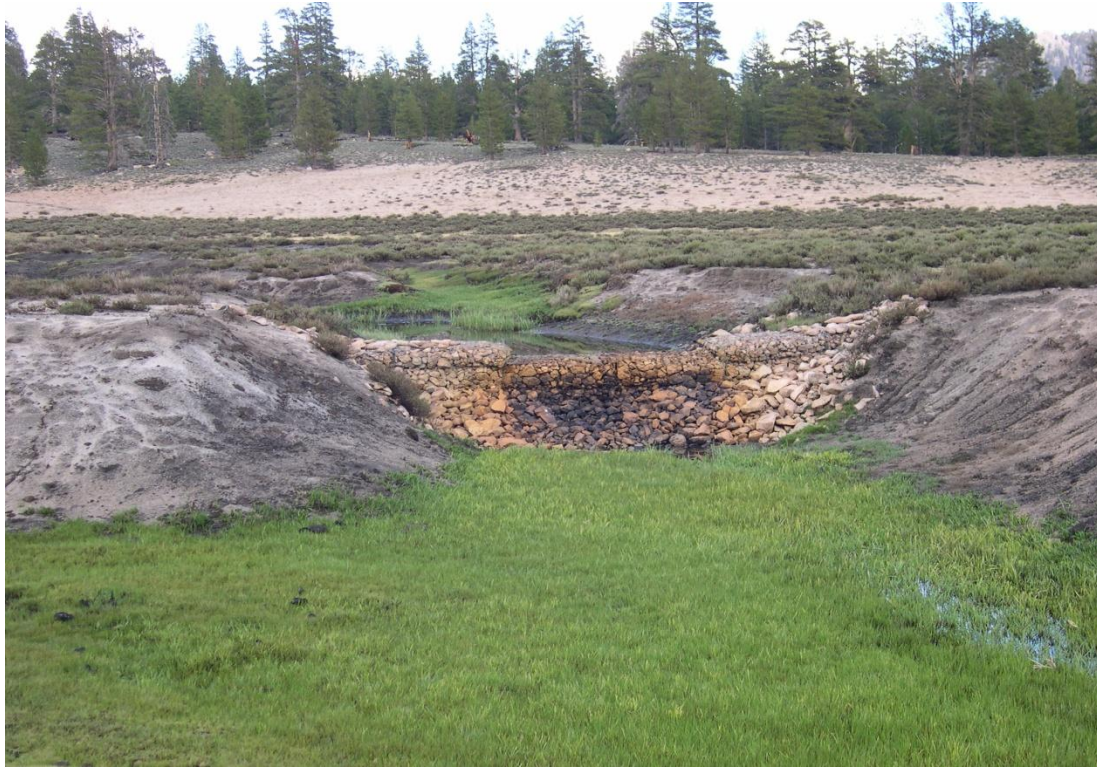
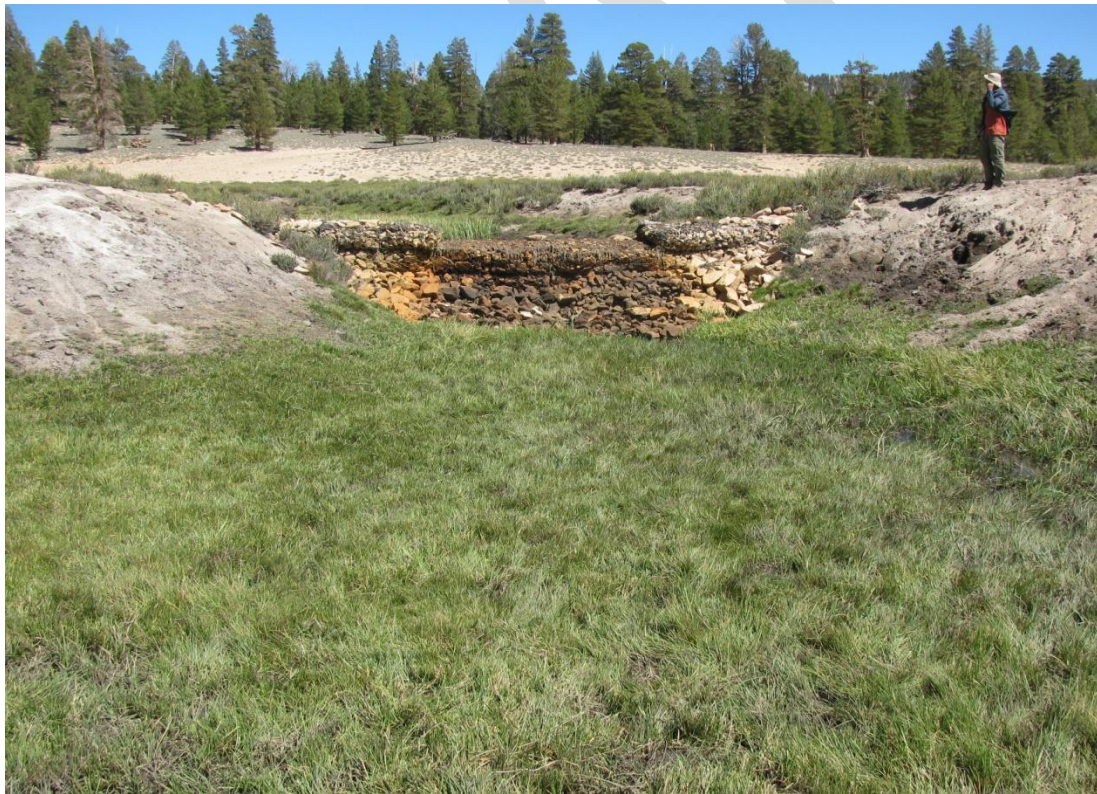
Above photo: Gabion check dam built in 1980's on deeply incised but recovering tributary to Mulkey Creek (Cow Camp Creek), August 2003. **Below photo:** Gabion check dam photo re-taken August 2011. Appears recovering floodplain in incision is slowly aggrading. Recent flood in July 2011 has damaged the spillway apron structure and may cause undermining of dam from next large peak flow. Piping of water is occurring beneath the structure.

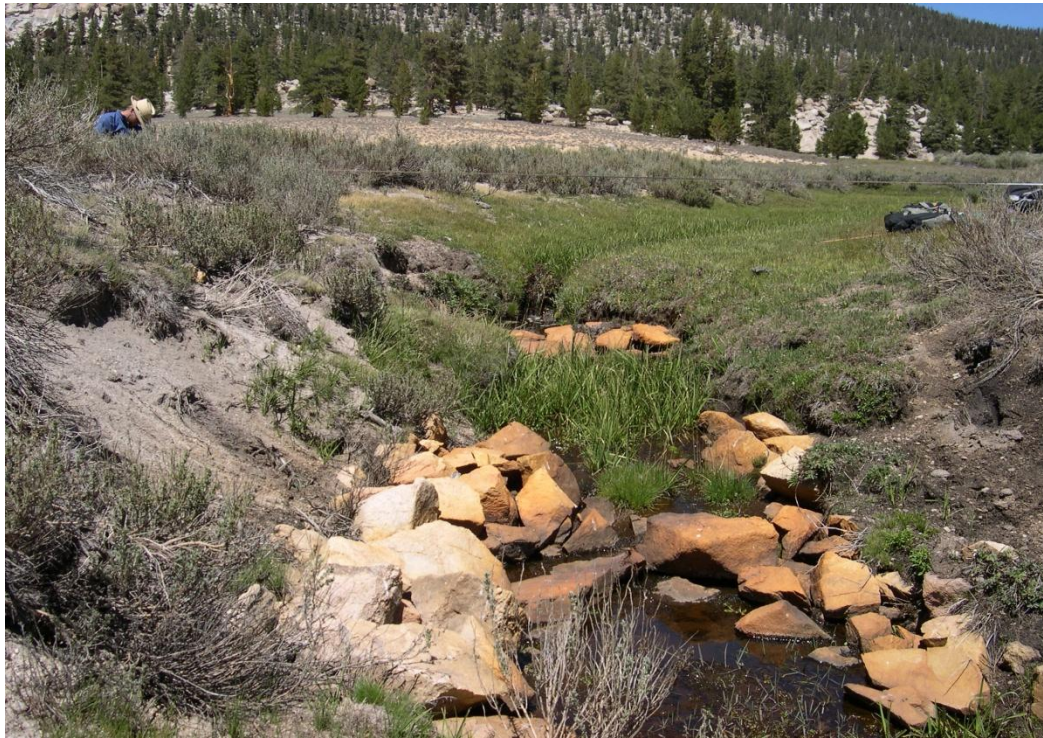
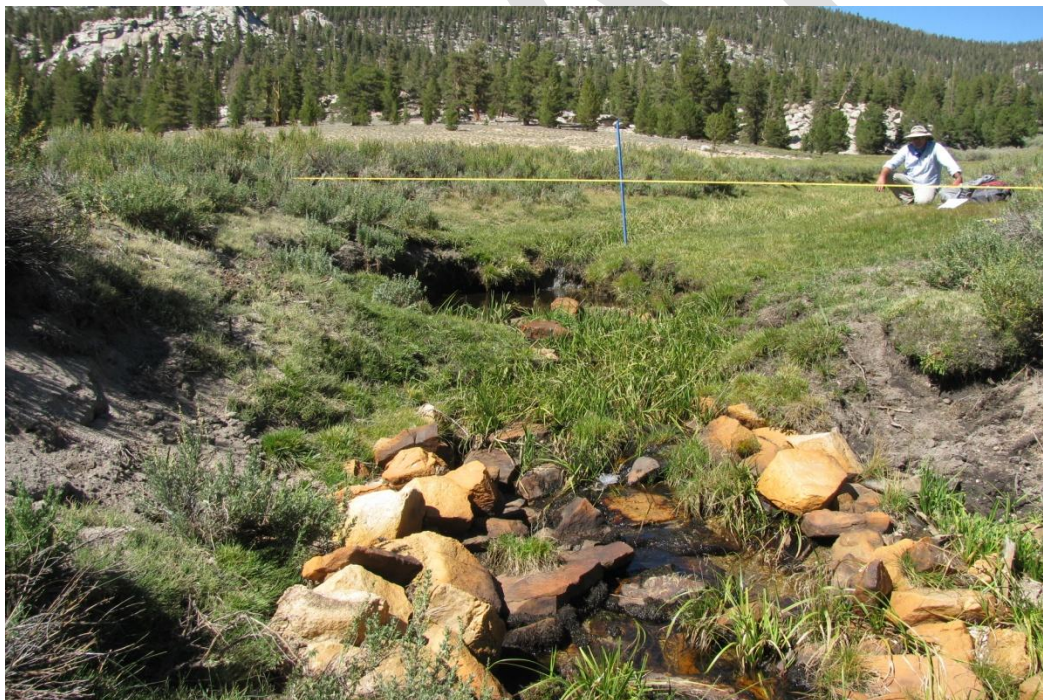
Above photo: Headcut 371 (HC-371) Mulkey Meadow on Cow Camp stringer, August 2003. Headcut formed after treatment of original headcut failed and HC resumed migration upstream. **Below photo:** Retake of photo HC-371 August, 2011. HC has migrated slowly (0.52 meters) likely due to resistance of a dense, well-developed sod layer and deep vegetative rooting in rebuilding floodplain above HC that helps to hold fine, organic subsoil. This HC could be retreated and if done correctly would have a high probability of success. Riparian vegetation has shown a slight increase in growth. Headcut face is more eroded and wider than in 2003.
